By Tony Crosby

FORT SELDEN'S EXTANT REMAINS

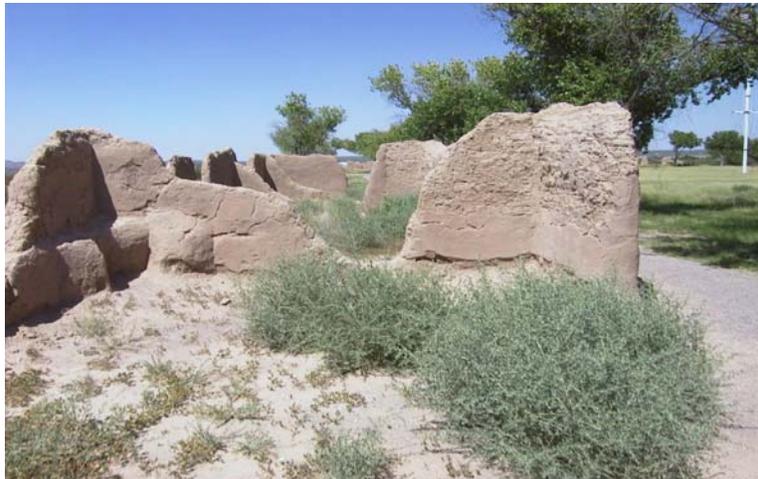
The extent of the adobe walls at Fort Selden vary from some walls in the area of the company quarters (Figure A3.1) that are 10 feet above grade to standing walls in fragments (Figure A3.2) to walls in the corral area that are only inches high and inches thick (Figure A3.3). The

Figure A3.1. Walls of the company quarters. These walls are the largest walls remaining.

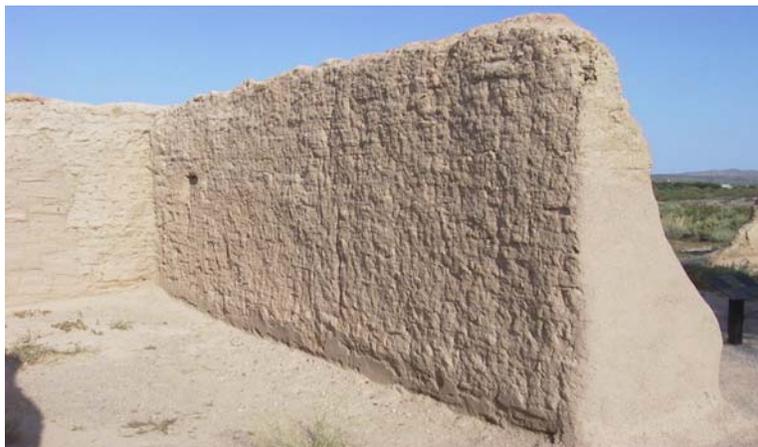
Figure A3.2. Adobe walls of the hospital. These walls are typical in size of most of the structure's remaining walls

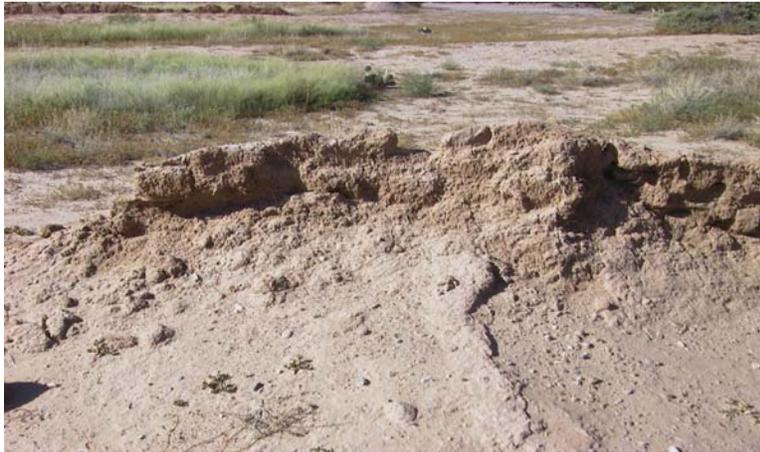
Figure A3.3. Fragments of adobe walls that are only inches high and thick.

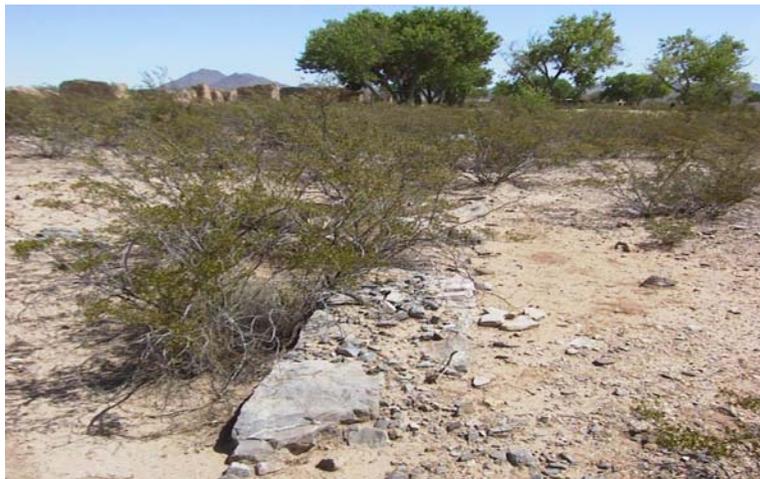
remains of adobe walls that exist at grade also continue to erode. Grade level stone features include the foundations of the commanding officer's quarters (Figure A3.4) and subsurface features that have yet to be explored fully.

Figure A3.4. Stone foundations of the commanding officer's quarters.

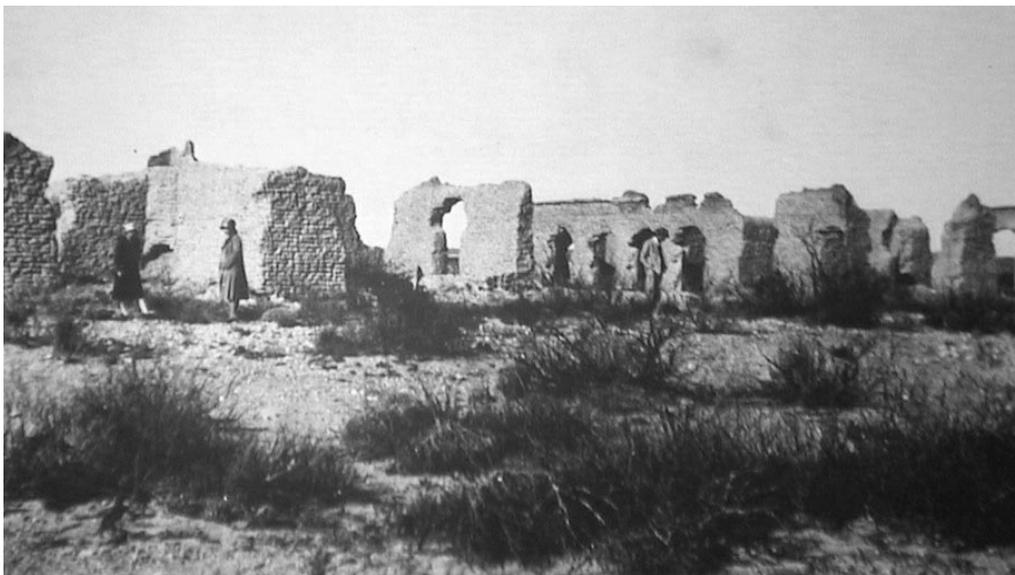
Deterioration occurring after the earliest available photographs in the 1920s (Figure A3.5) easily can be seen. Since that time walls have collapsed, wall openings that represented previous doors and windows have been reduced to low walls connecting higher wall fragments, wall heights have reduced greatly, and the wall

Figure A3.5. Photograph of Fort Selden in the 1920s. Note the door and window openings.

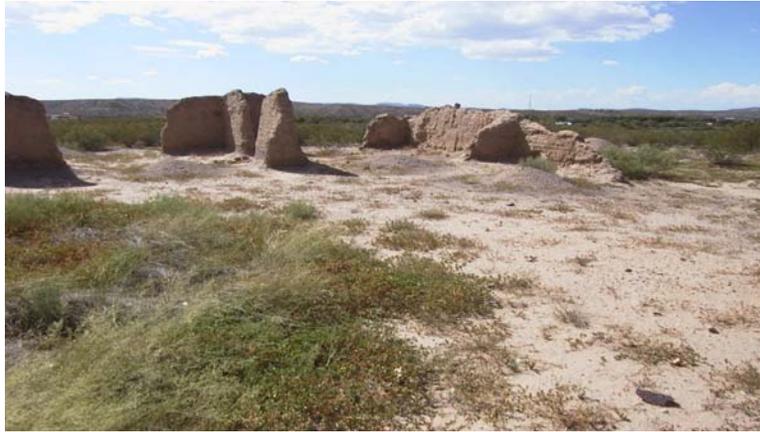
thicknesses have eroded differentially, often to less than half the original thicknesses (Figure A3.6). The actual rate of decay appears to be relatively constant over the past hundred years, but certainly times have occurred when wall collapses resulted in greater losses over relatively short periods. Nevertheless, adobe typically decays relatively constant over long periods, followed by accelerated decay over relatively short periods. Eventually the overall loss of cohesion at the building features results in accelerated losses until the features no longer exist. A majority of the wall fragments at Fort Selden appear to be rapidly approaching this phase.

Figure A3.6. Present typical condition of the adobe walls of the officers quarters.

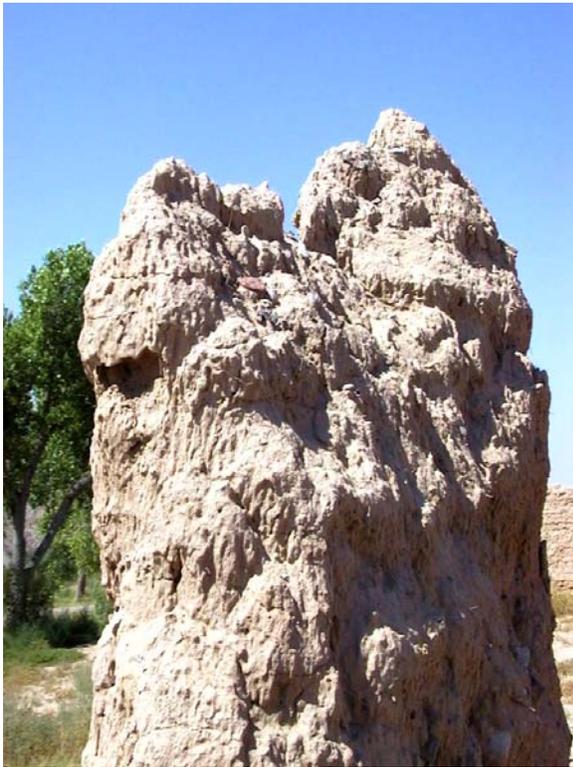
combinations of wind and rain, by side-loading such as high winds, and from human-related factors such as leaning or shoving. On the wall ends the portion below the clumps often cannot support the weight of the clumps, will fall from their own weight (see Figure A3.9). Someone pushing on the walls probably displaced the ends of several walls in the officers quarters.

Figure A3.9. Clumping of an end wall that soon will result in loss.
