### PUBLIC INVOLVEMENT AND AGENCIES CONSULTED

### MEETING SUMMARY

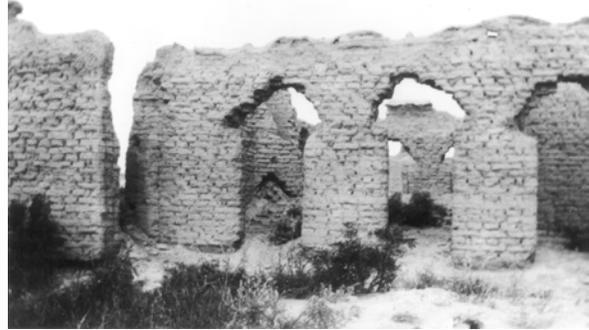
Deterioration of the structures can be seen since photographs were made of them in the 1920s (Figure 9).

*Figure 9. This photograph was taken by Gertrude Hill on July 4, 1926, only 35 years after Fort Selden was abandoned. Courtesy of Museum of New Mexico, Negative No. 1794*

Since that time walls have collapsed, wall openings representing former windows and doors have been reduced to low walls connecting higher wall fragments, wall heights are greatly reduced, and wall thicknesses have eroded differentially, often to less than half their original thickness. While the rate of decay appears to be relatively constant over the past hundred years, some wall collapses have resulted in greater loss over relatively short periods. Adobe decay is relatively constant over long periods followed by accelerated decay over relatively short periods, until the building features reach a state of overall cohesion loss followed by accelerated loss until the features no longer exist. The majority of the wall fragments of the Fort Selden ruins appear to be rapidly approaching this phase of the decay process.
