By Tony Crosby

FORT SELDEN'S EXTANT REMAINS

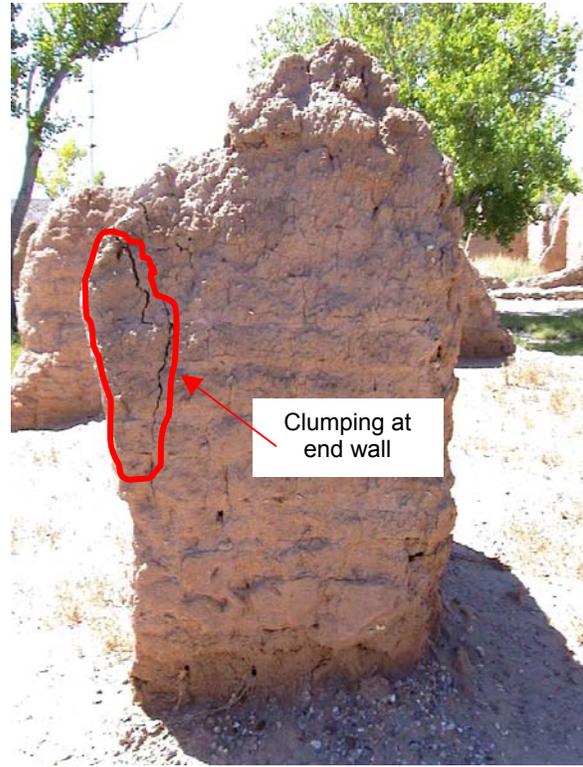
Clumping (Figure A3.8) results when wall portions that are not restrained by surrounding adobe wall mass are subjected to more water absorption. Without the restraining effect of the wall mass, the wall tops and ends can crack more severely and consequently become separated from the surrounding material, resulting in “clumps” of adobe material. The clumps are then subject to displacement by

Figure A3.9. Clumping of an end wall that soon will result in loss.
